East Fork Oxbow Project

Jason Richardson, P.E.

Location: Coos Bay, Oregon on the Weyerhaeuser Millicoma Tree Farm.

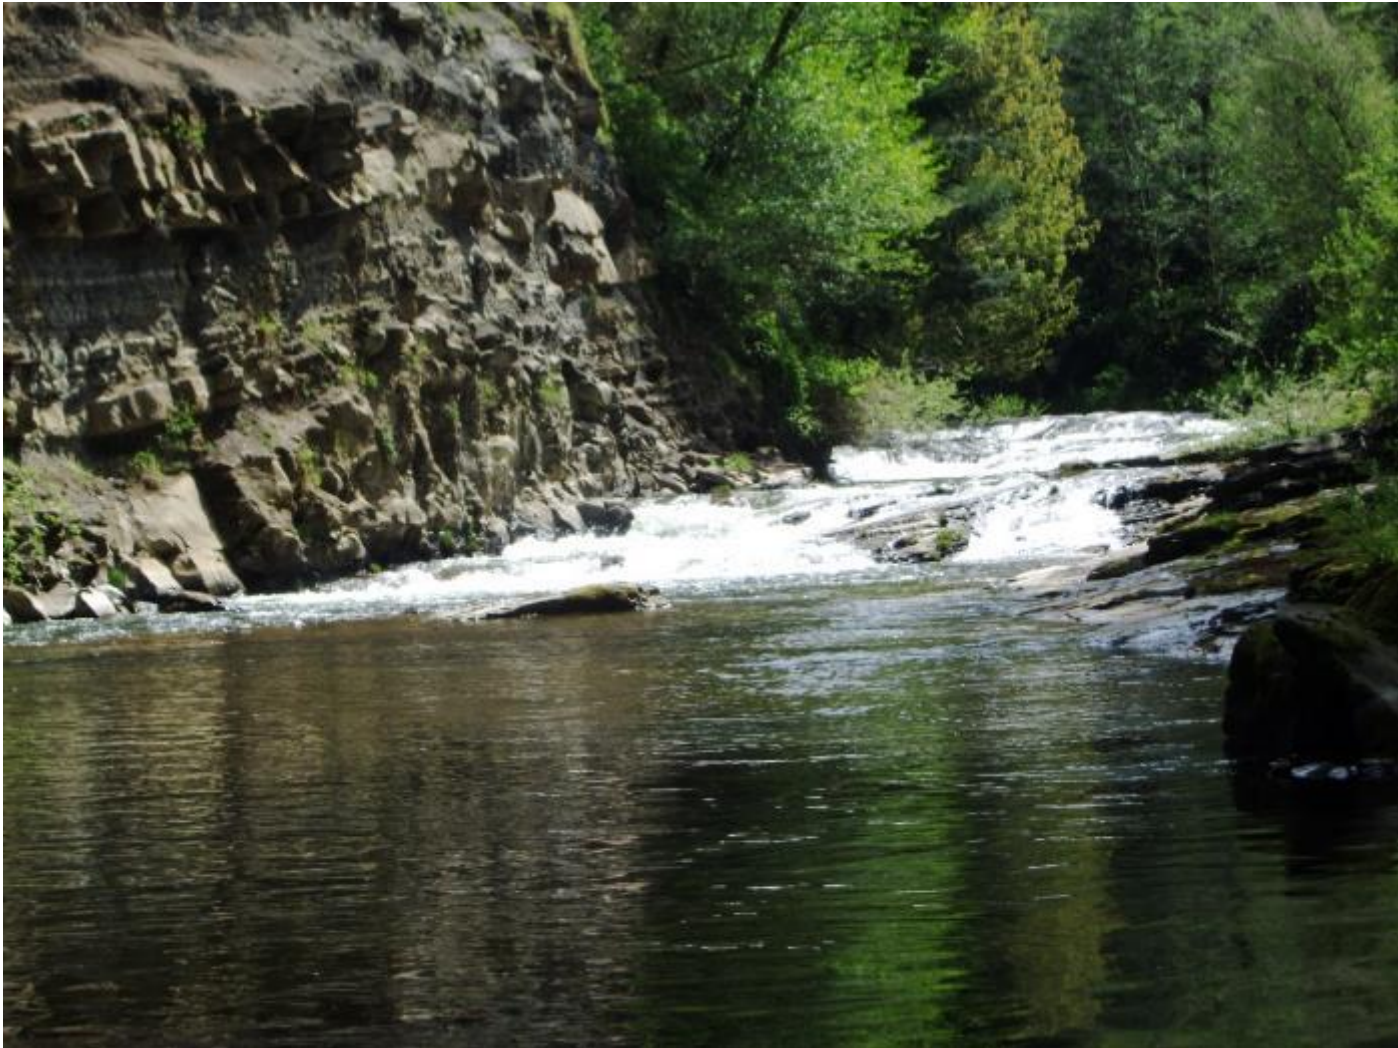
- **Bypass chute-drops 16ft in 150 yards over a series of 3 bedrock steps/shelves.**

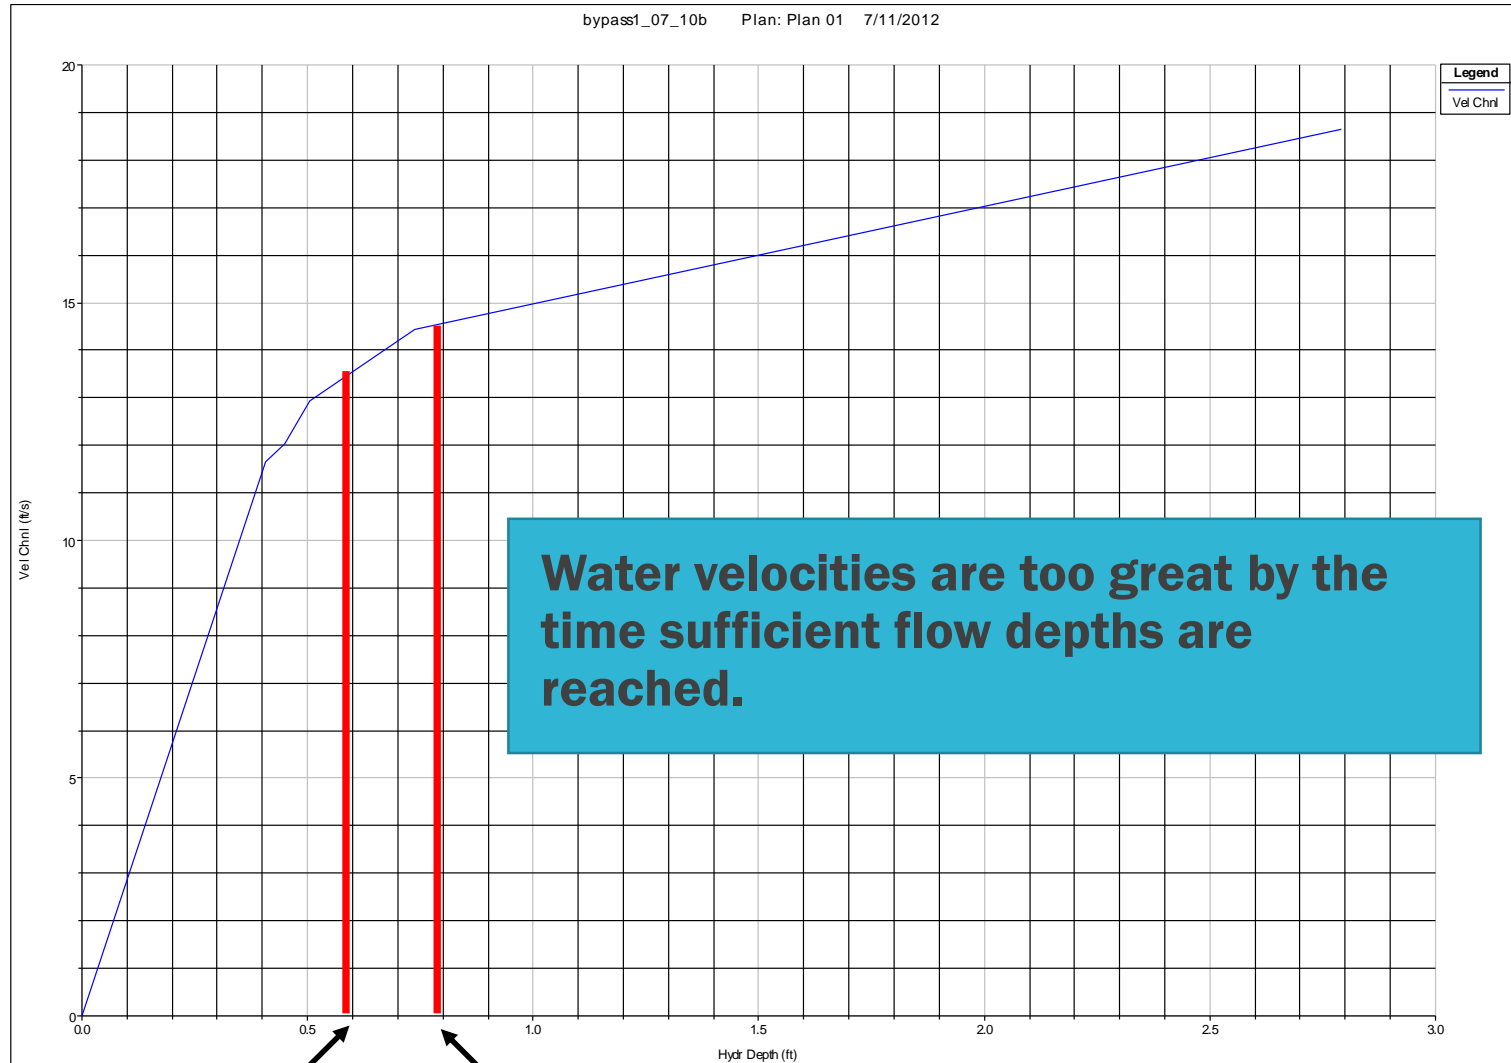
Fish Passage Limitation

Coho = 0.59 ft.

Chinook = 0.79 ft.

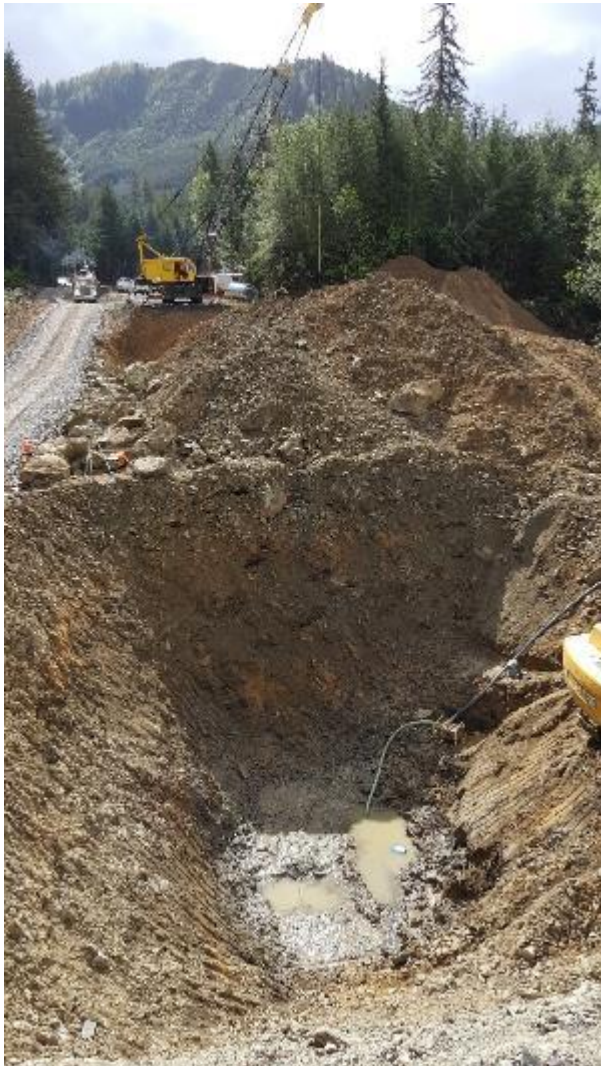
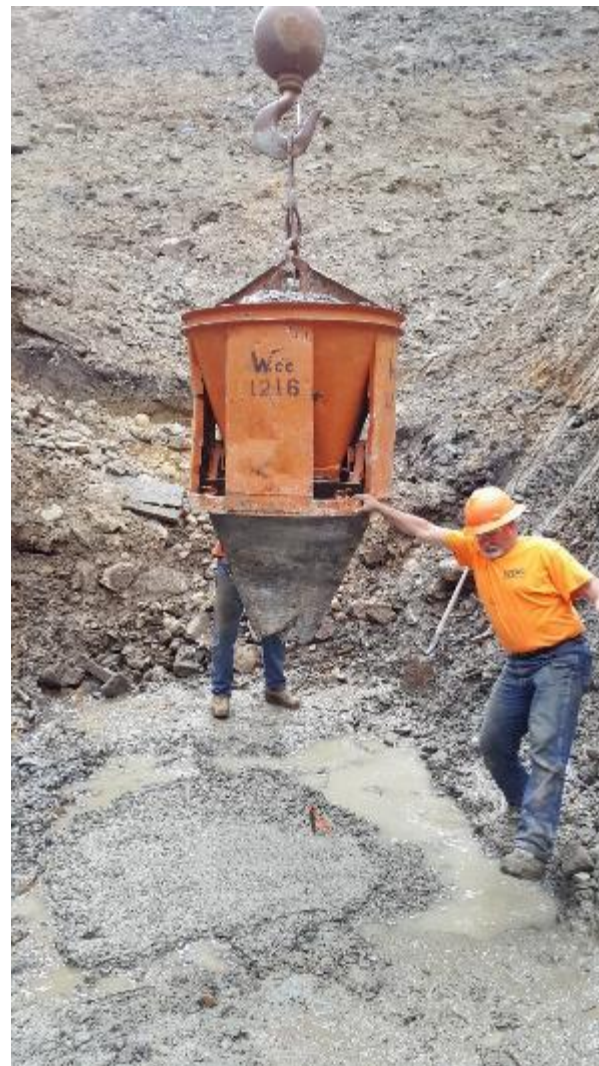
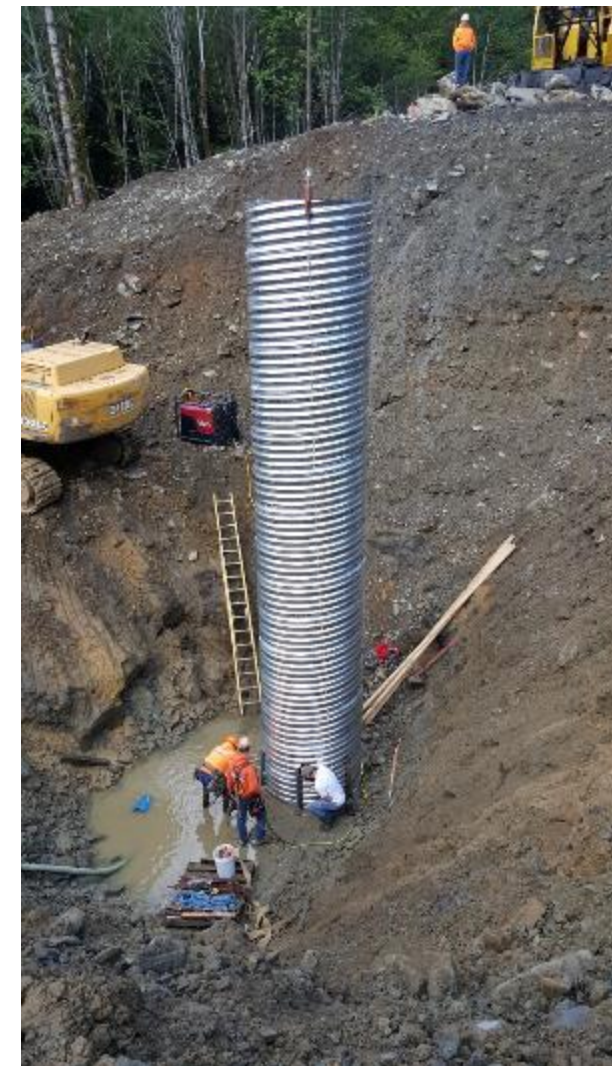
- **Bridge #4 Constructing bent #2.**
- **Approx. 5,000 yds. of fill and challenged with working below river grade.**

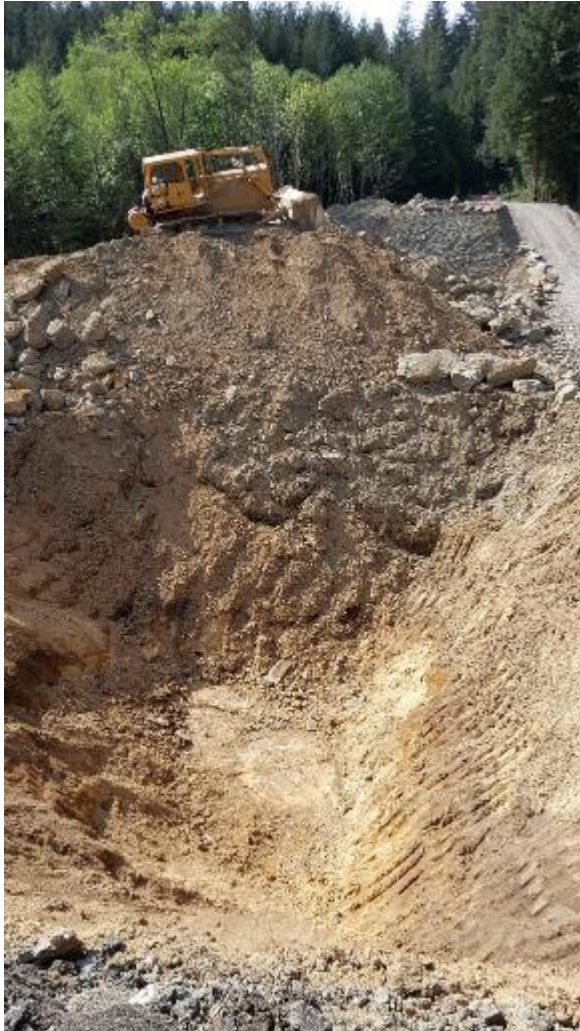
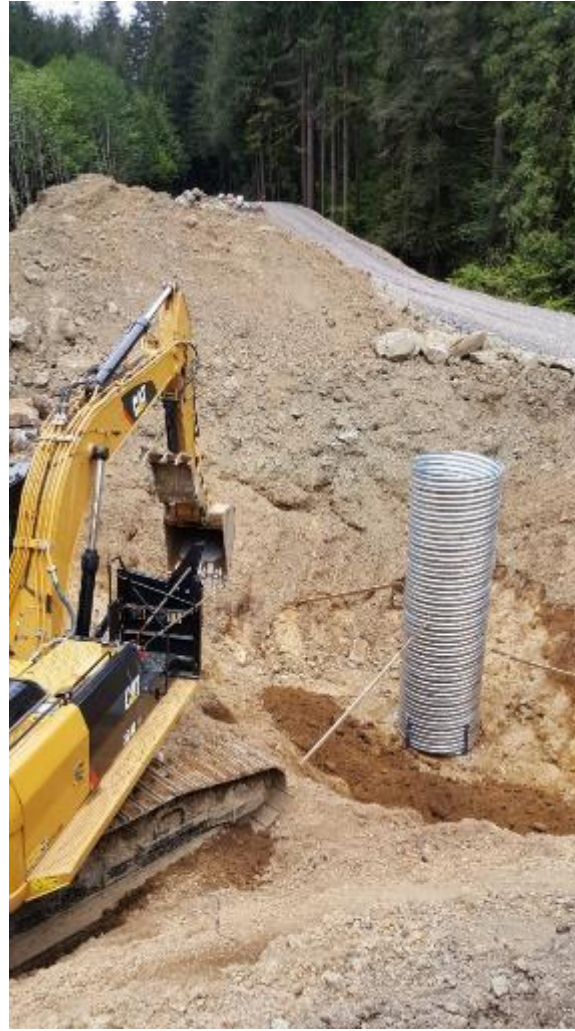
- **Bridge #4
Constructing
bent #3.**
- **Approx. 5,000
yds. of fill.**
- **Dry hole.**

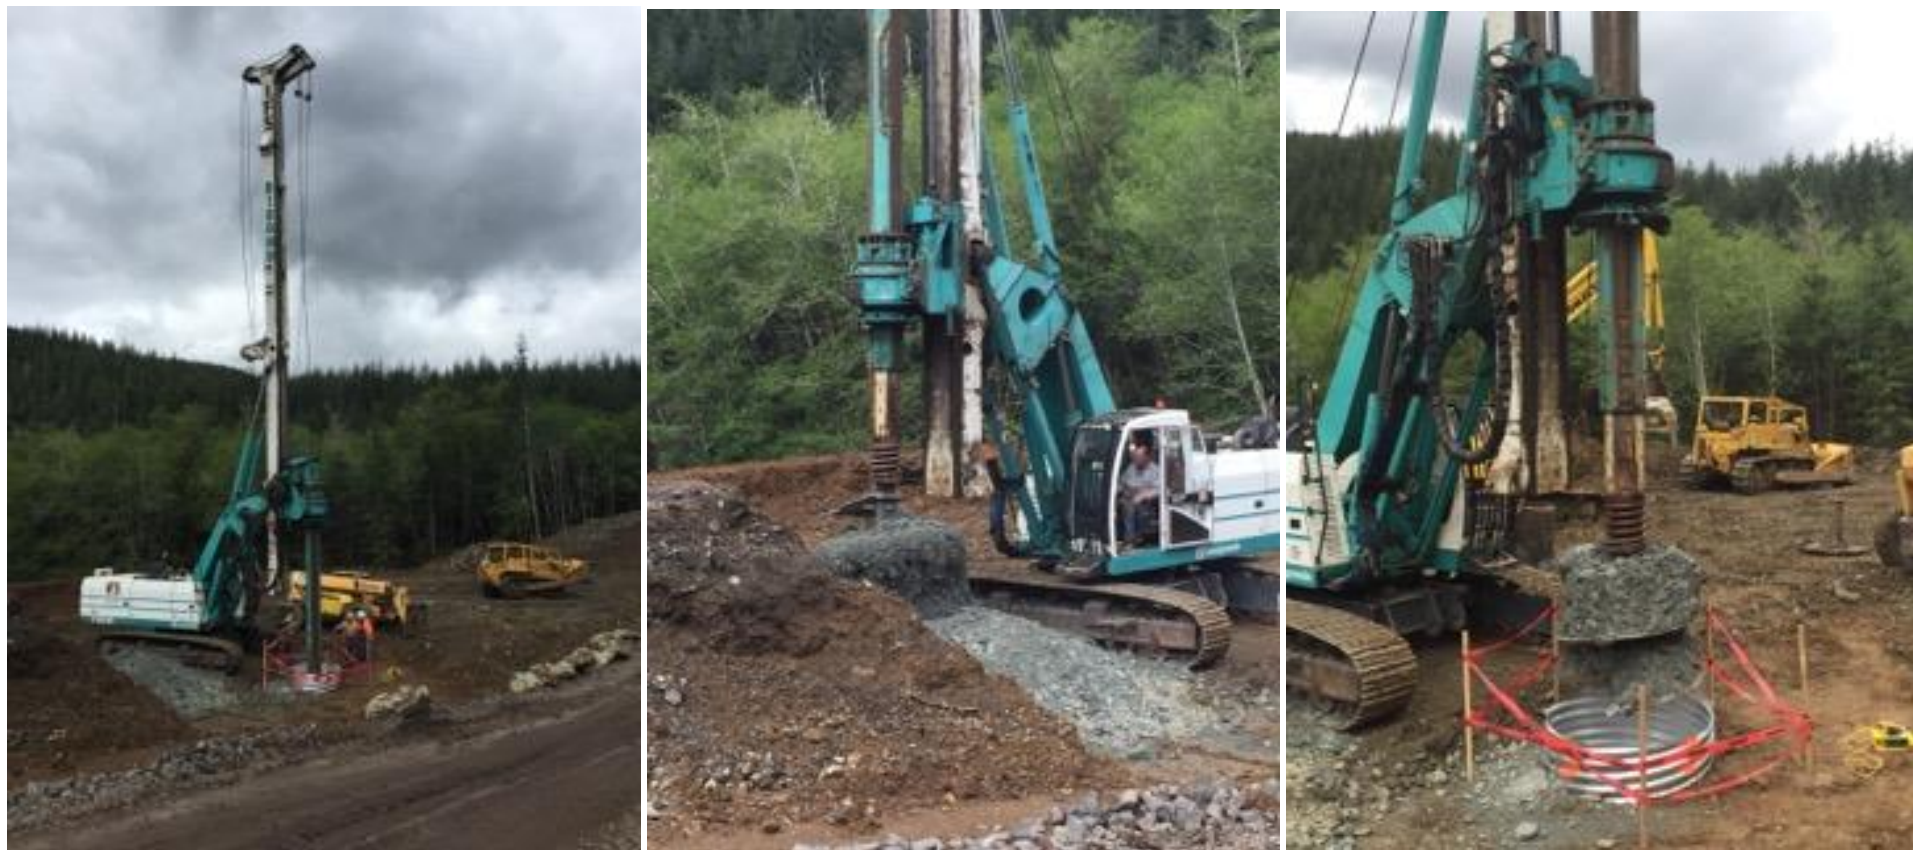
- **Bridge #4 bent #3 & #4 drilling the shafts.**
- **Each holes takes about 1 day to drill and clean out.**

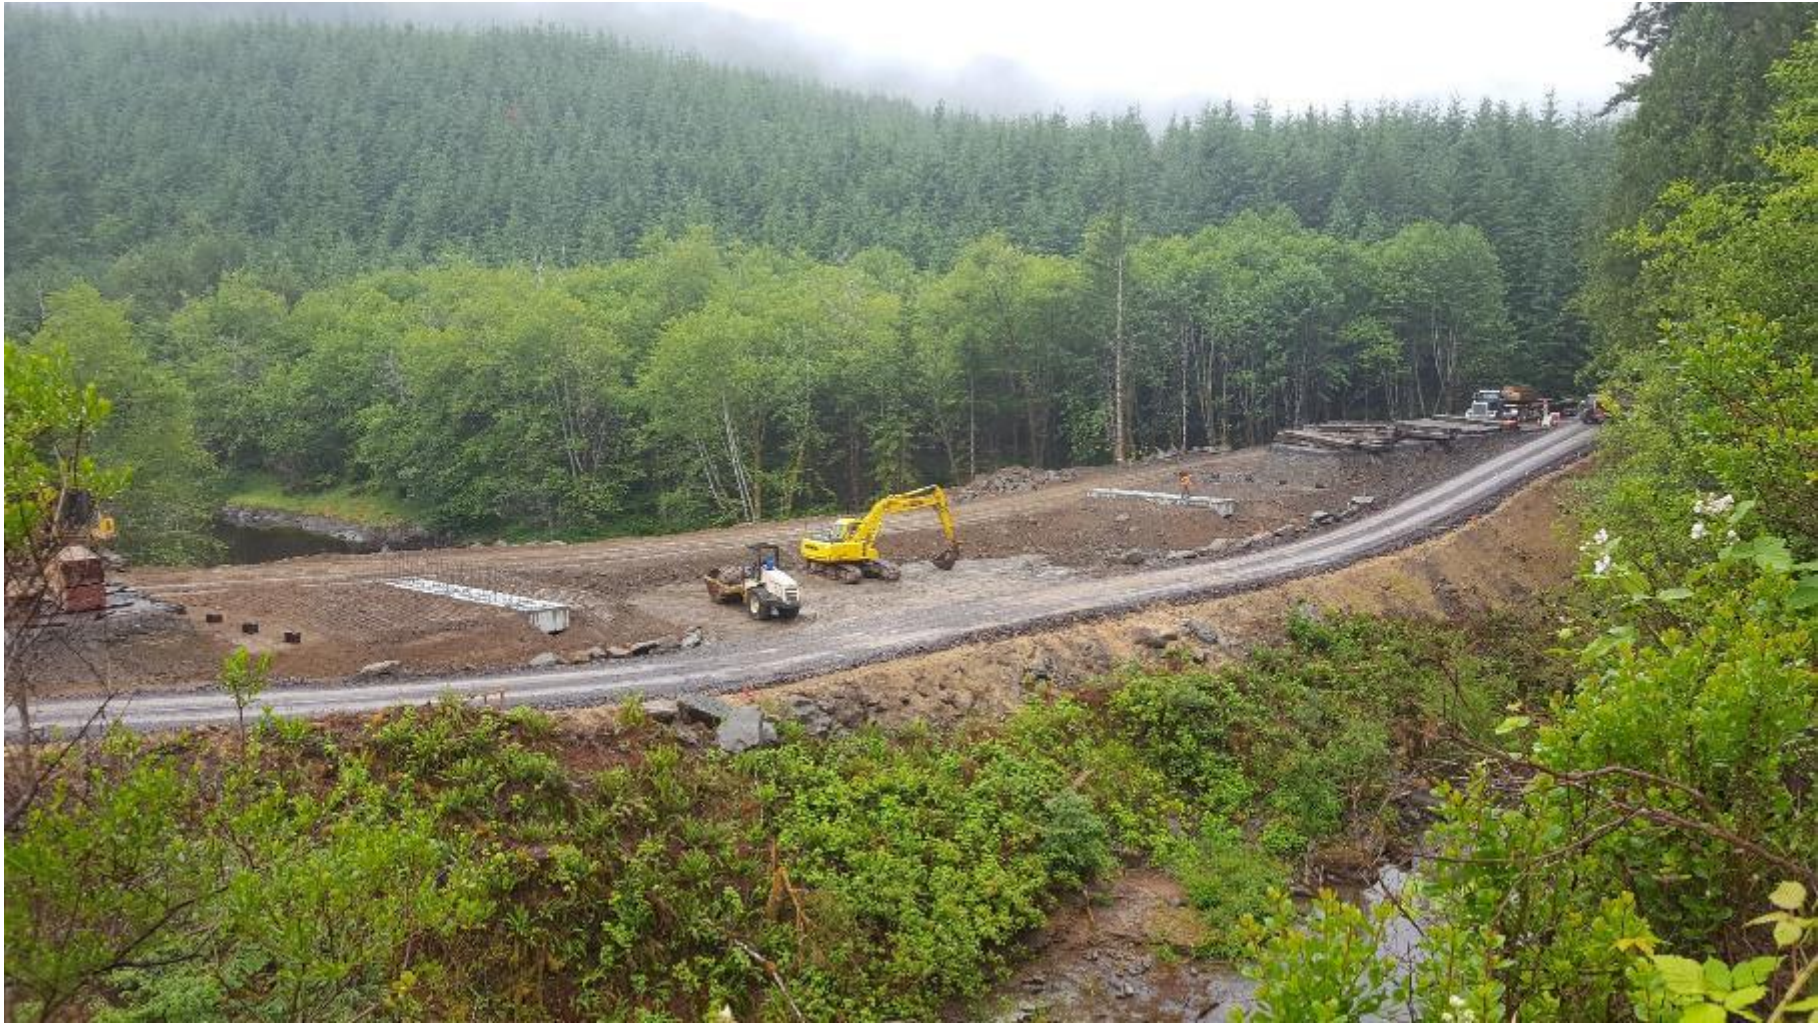
Bridge #4 bents 1 & 4 pile driven, bents 2 & 3 piers and hammerheads completed.

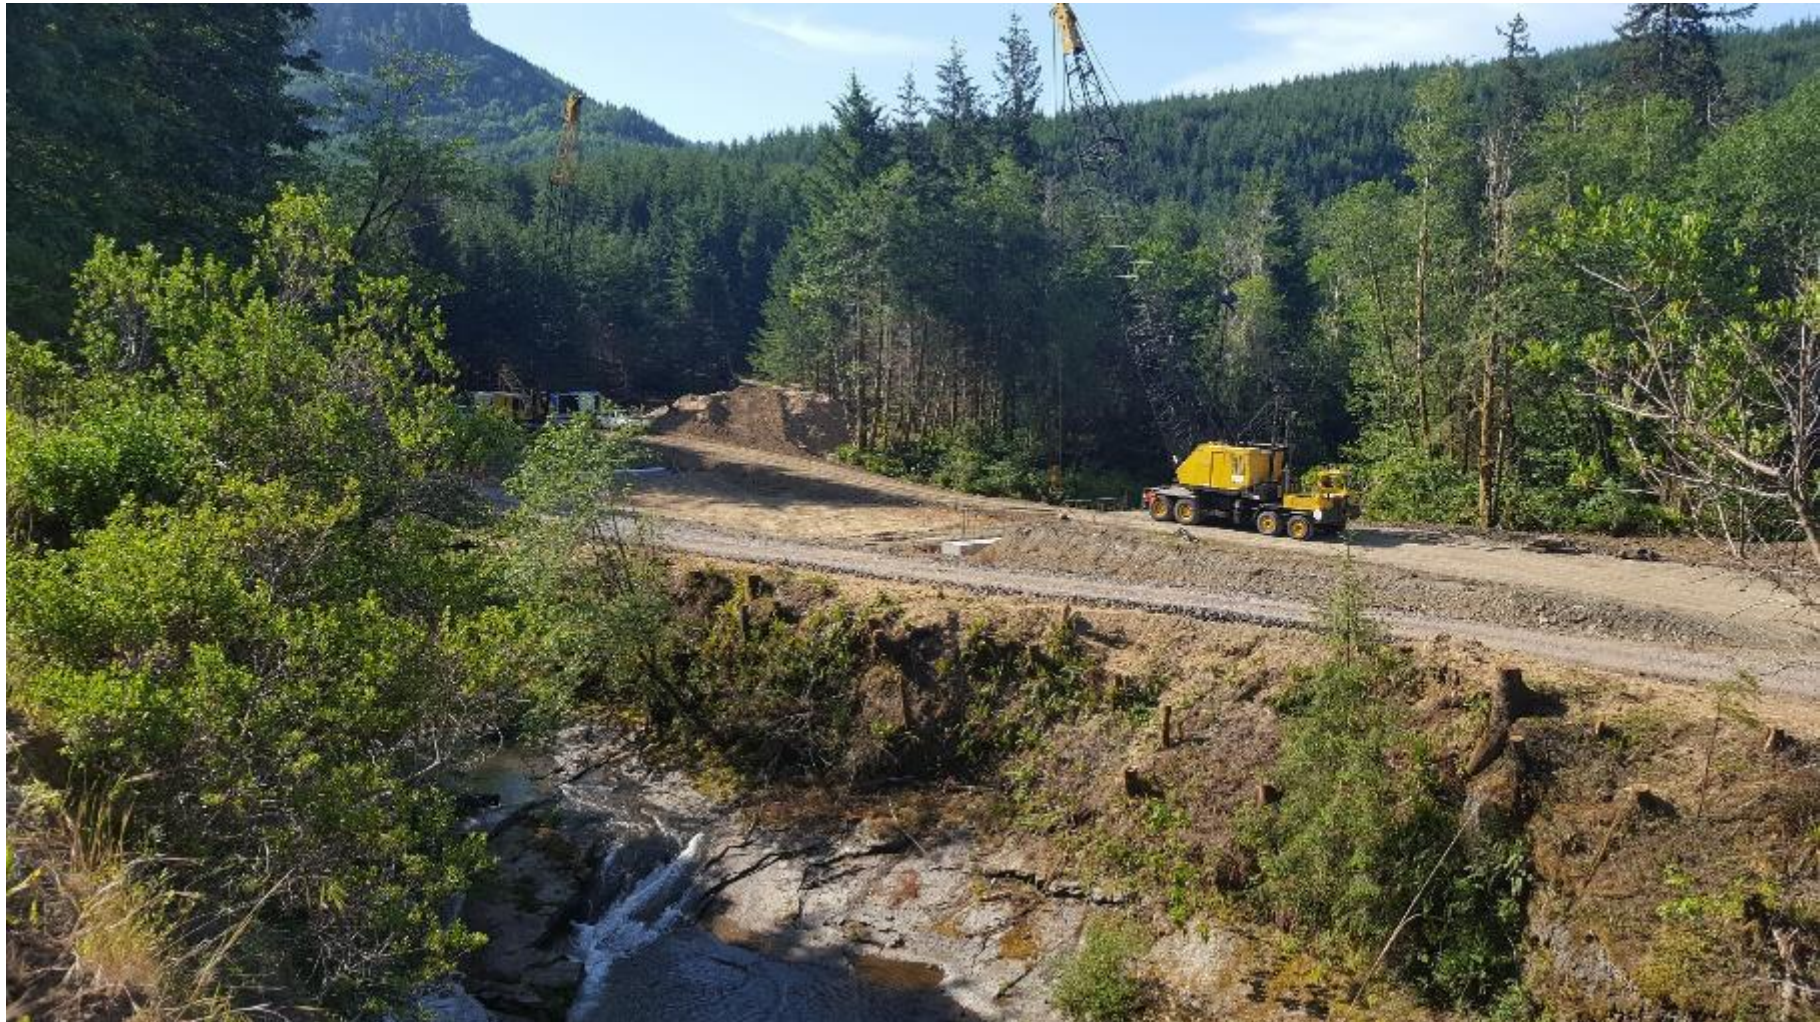
Bridge #5: HP14x117 driven piles at 6ft-6inch centers with cast in place concrete bents.

Bridge #5 bents 1 & 2 pile driven and concrete bents poured.

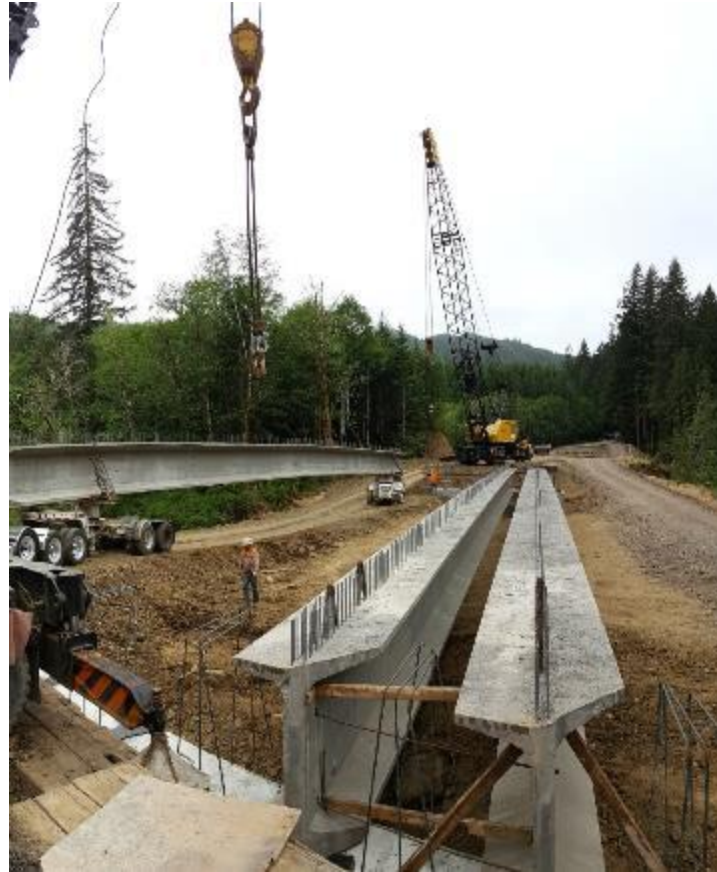
- Knife River trucked in the 150 ft. long bulb-T girders with manned steer cars with an overall length of 195 ft.
- Two cranes were used to place girders on bents into their permanent locations.

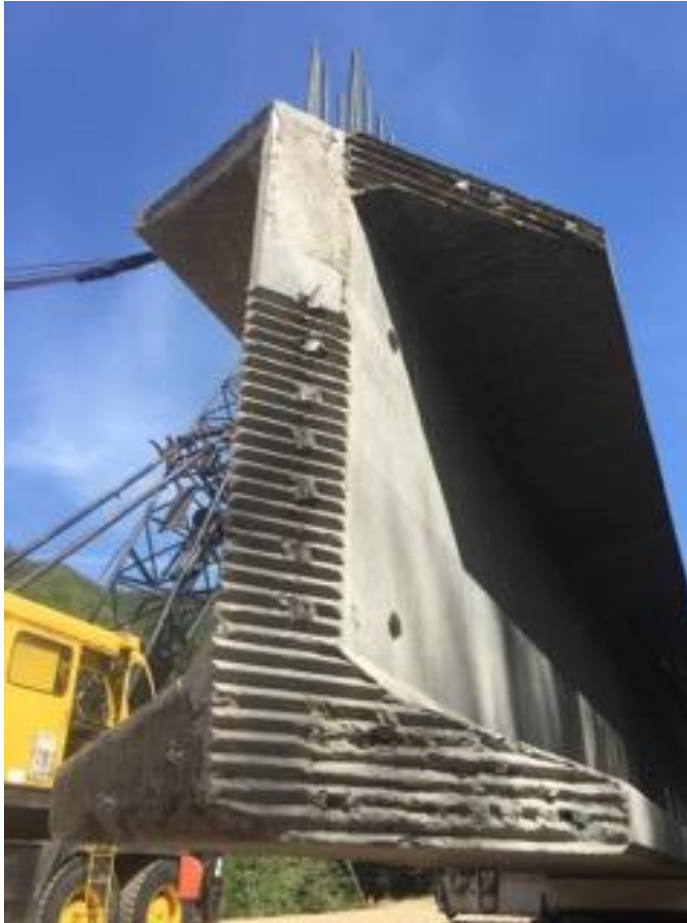
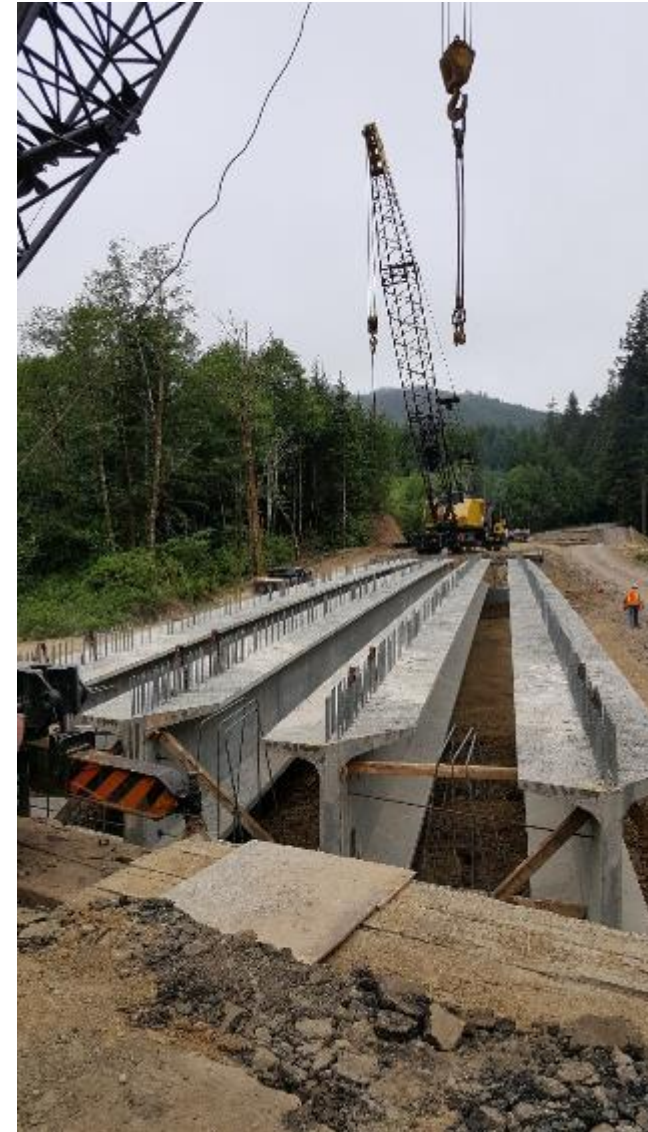
Knife River Bulb-T Girders

- Knife River provided the semi used beams to this project for a discounted rate.
- Beams had to be retro fitted to fit this location.

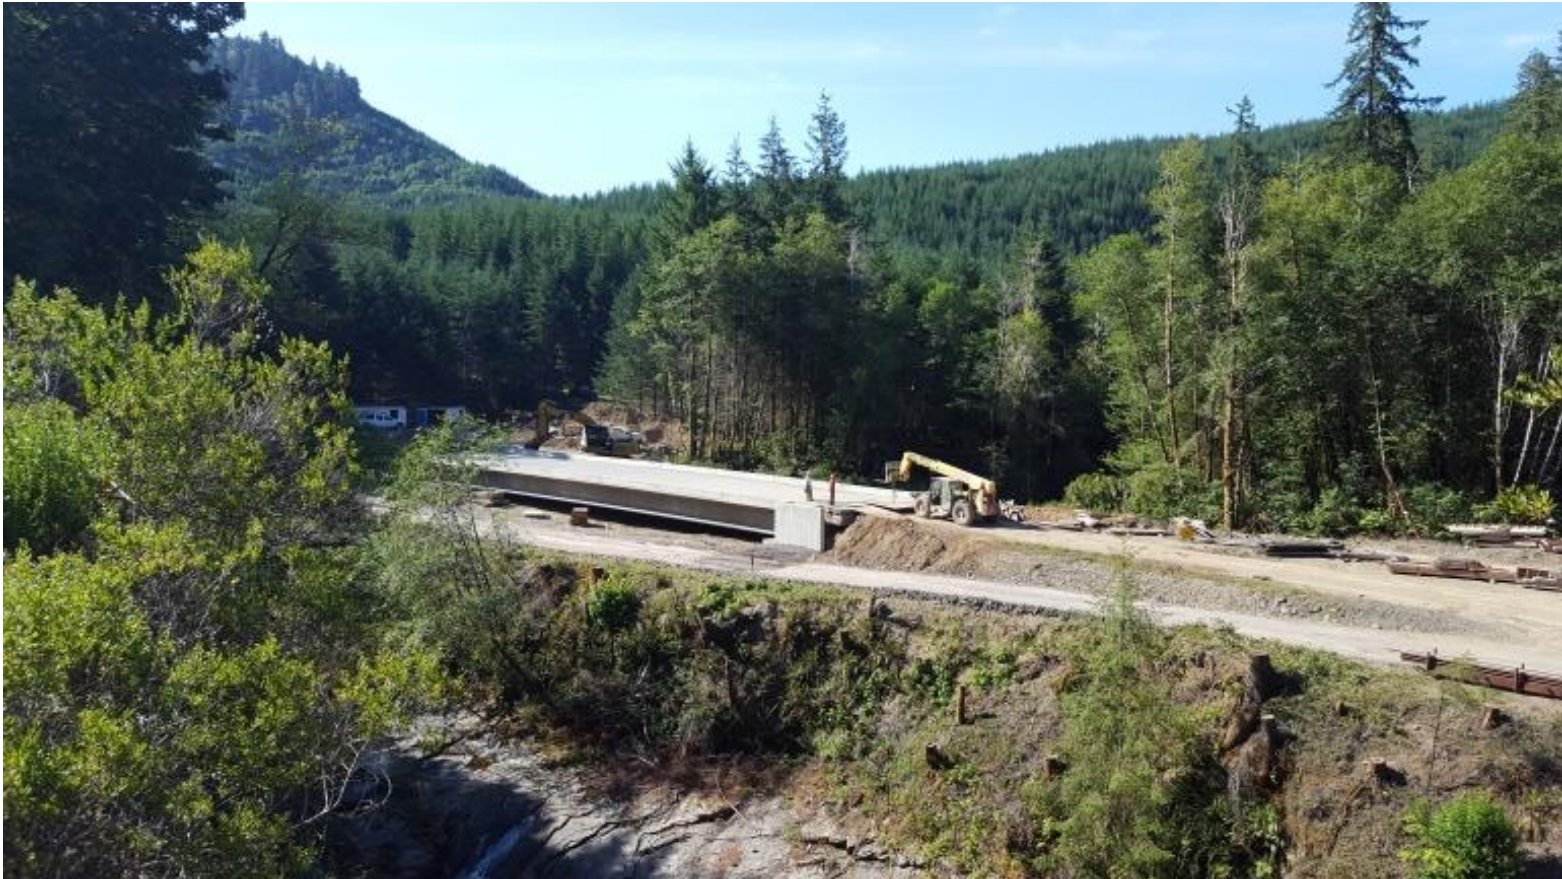
- **Bridge #5 Once the girders are set diaphragms and wing walls are constructed.**
- **On top of the girders false work was constructed to pour the deck and curbs.**

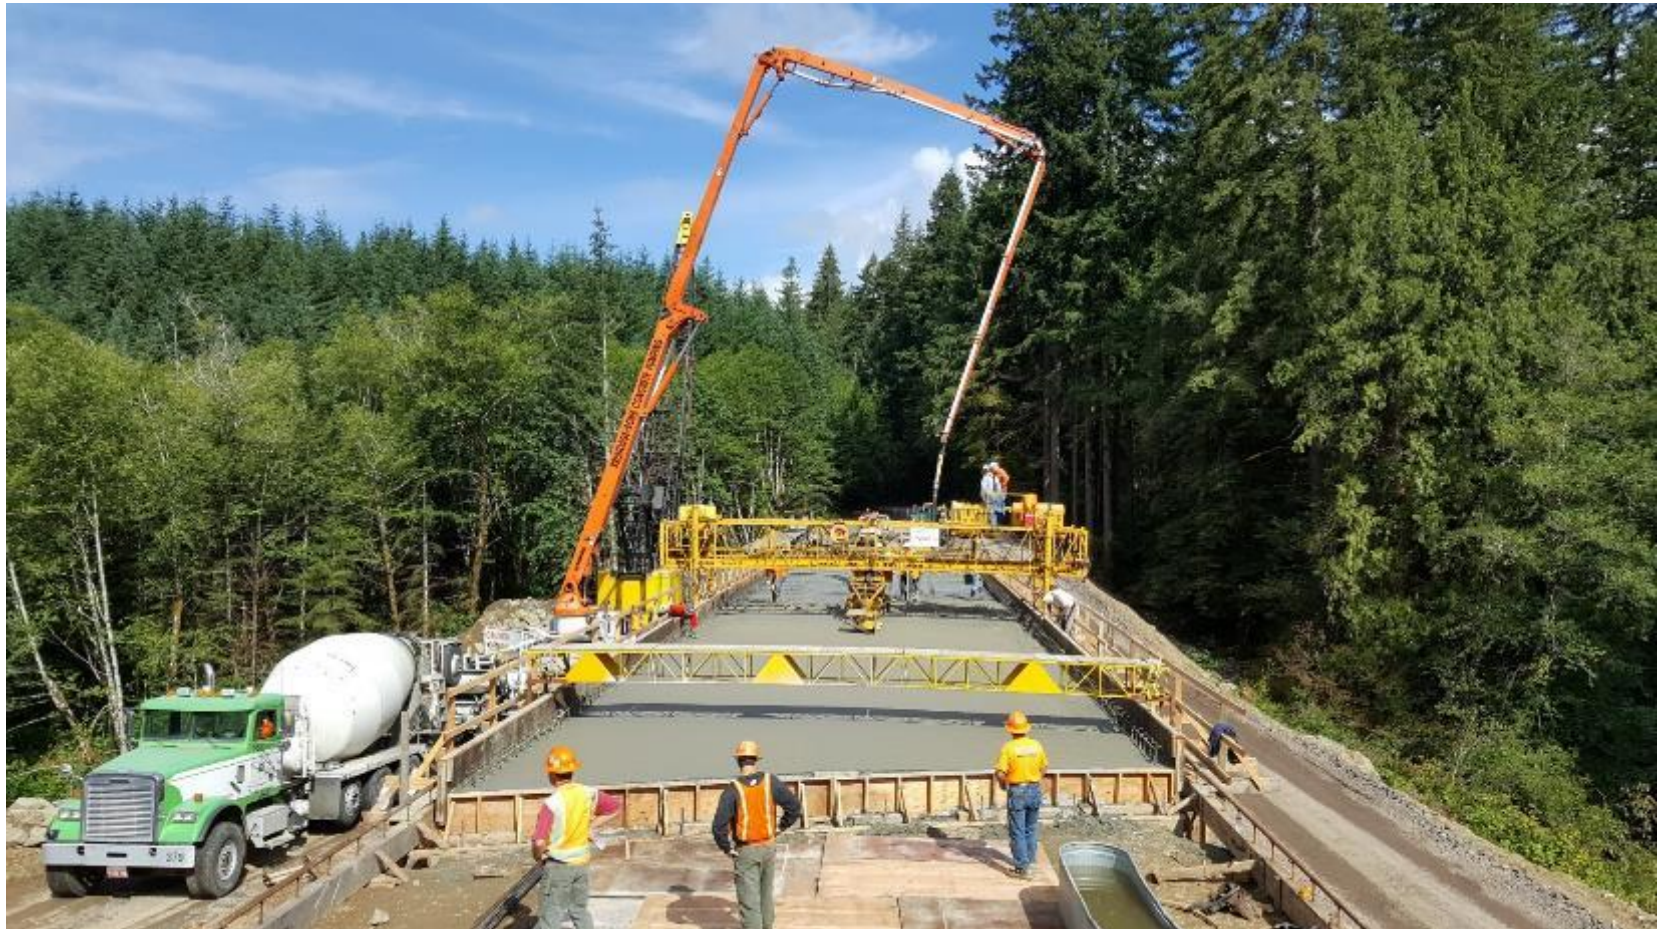
- **Bridge #4 Girders are set and diaphragms are poured.**
- **On top of the girders false work was constructed for the deck and curbs.**
- **Once span two is completed approach spans 1 and 3 are cast in place with curbs and wing walls.**

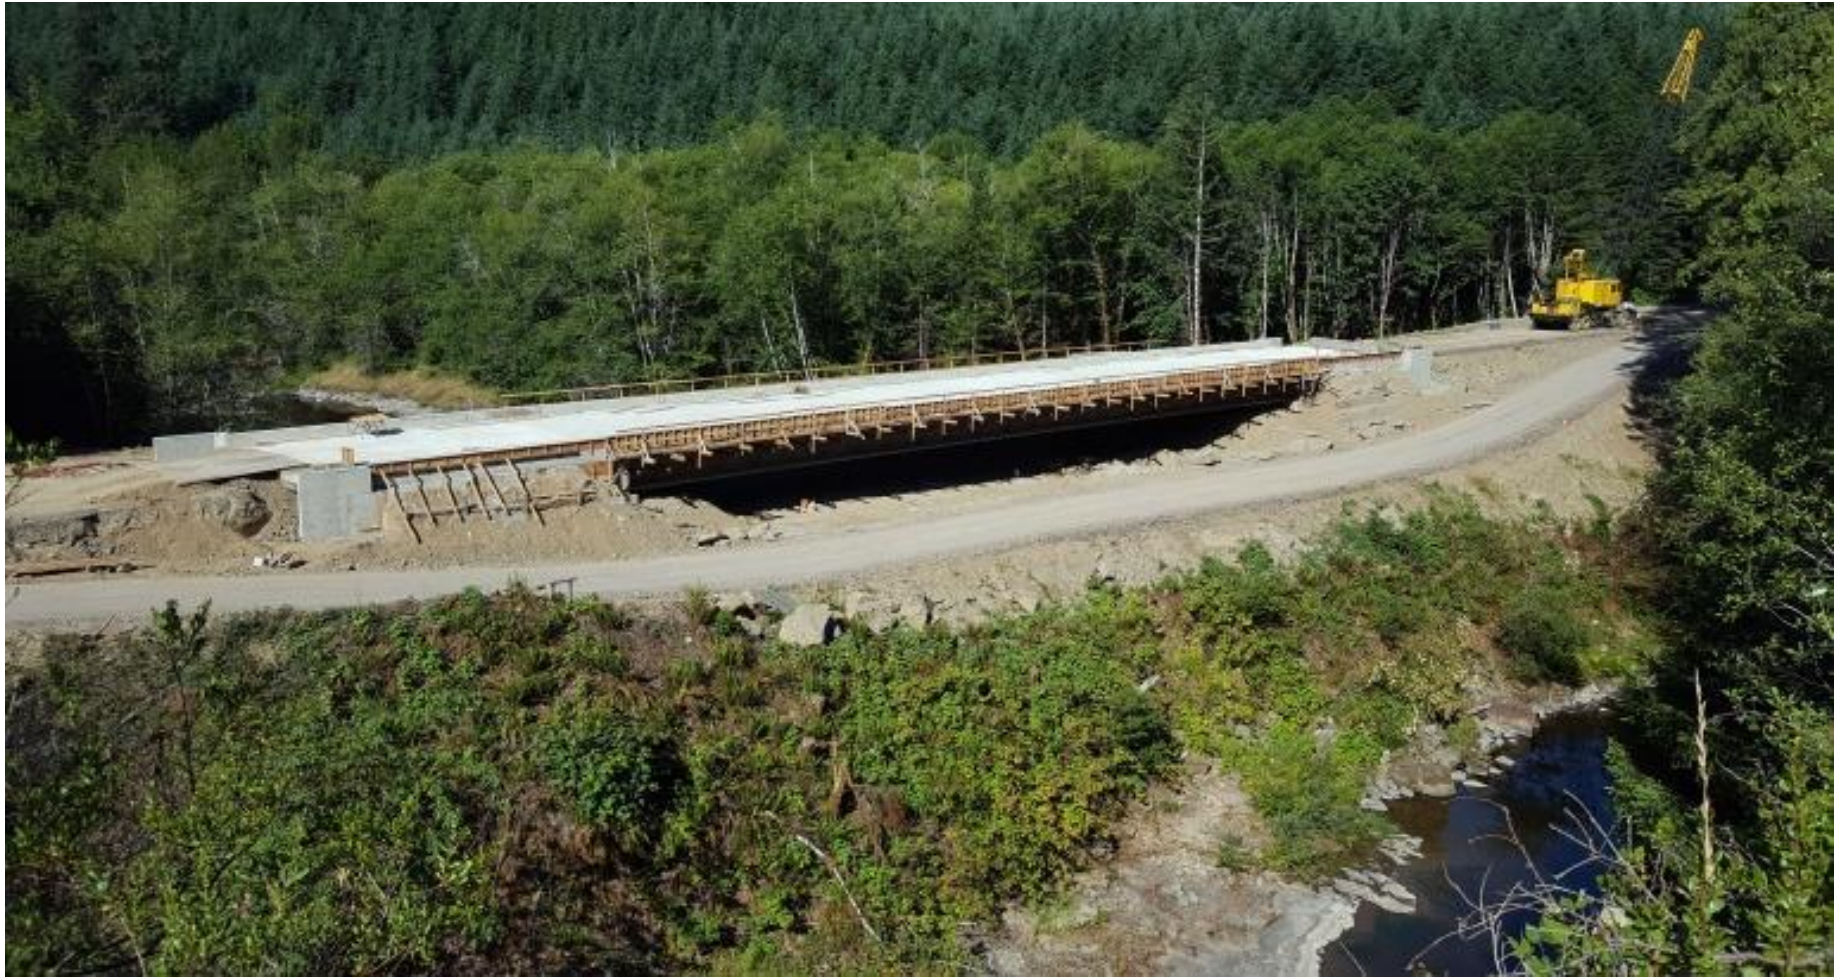
- **After the concrete is all poured, the concrete was lab tested for strength.**
- **Once the required strengths were reached the forms were removed and the bridge was ready for traffic.**

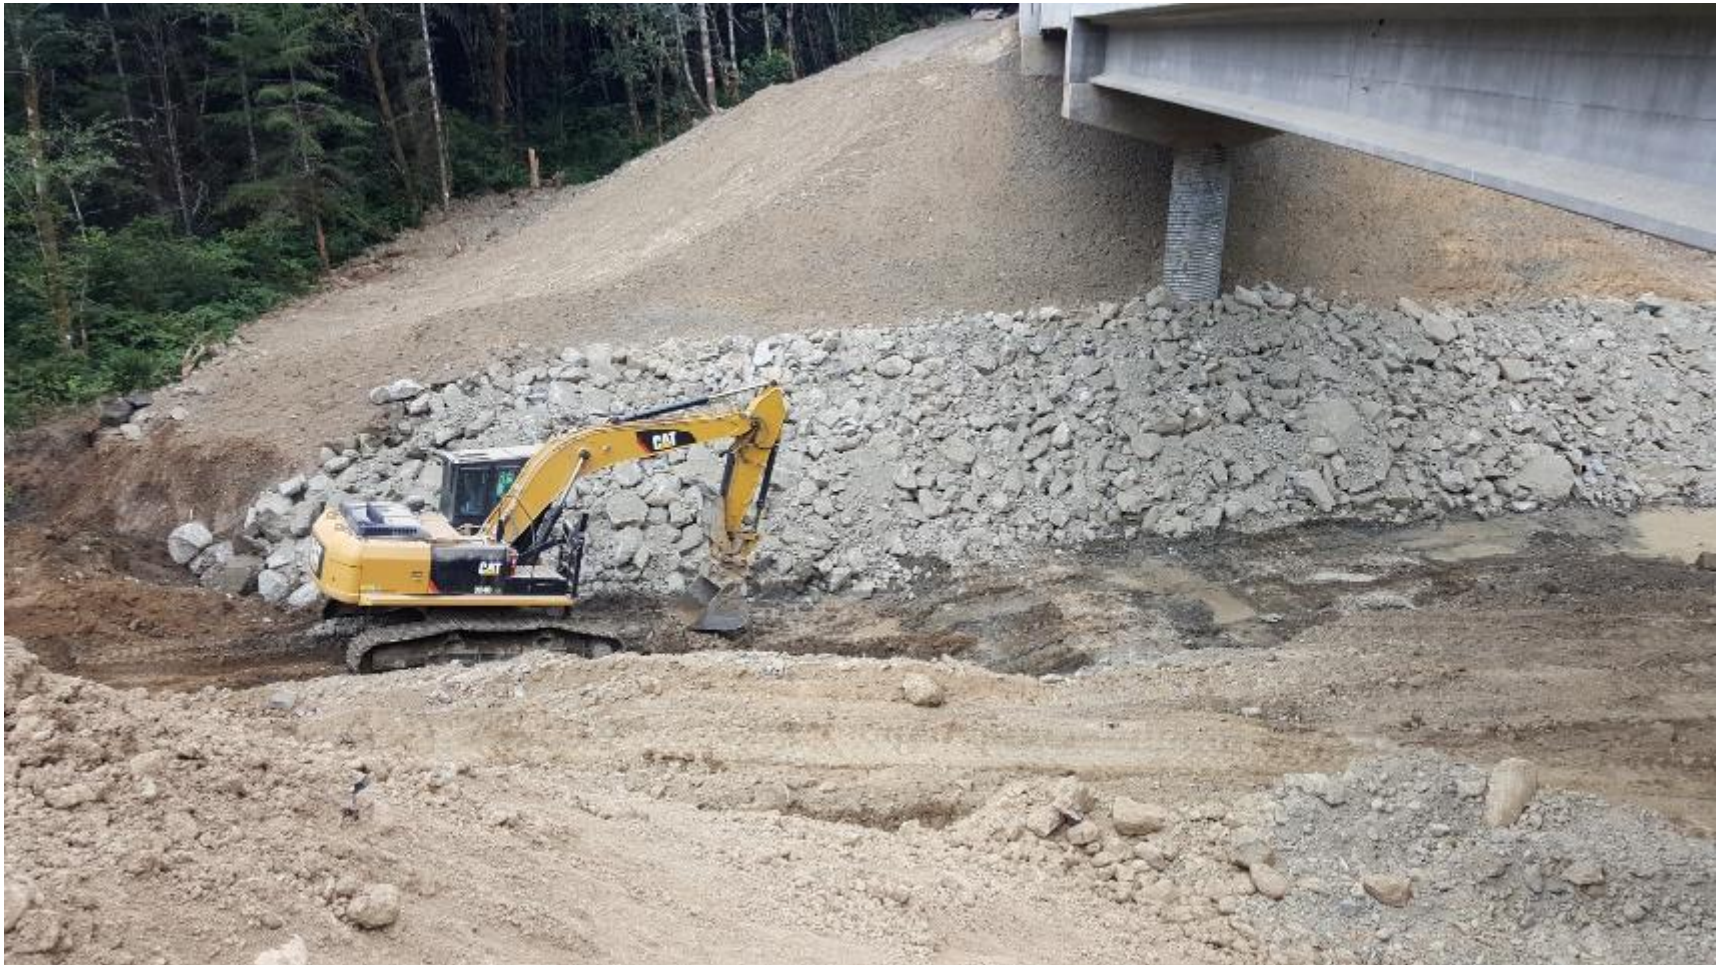
- **Once the fills were removed, but before river was re-introduced final rip rapping was placed under the bridges at a 1.5 to 1 slope.**

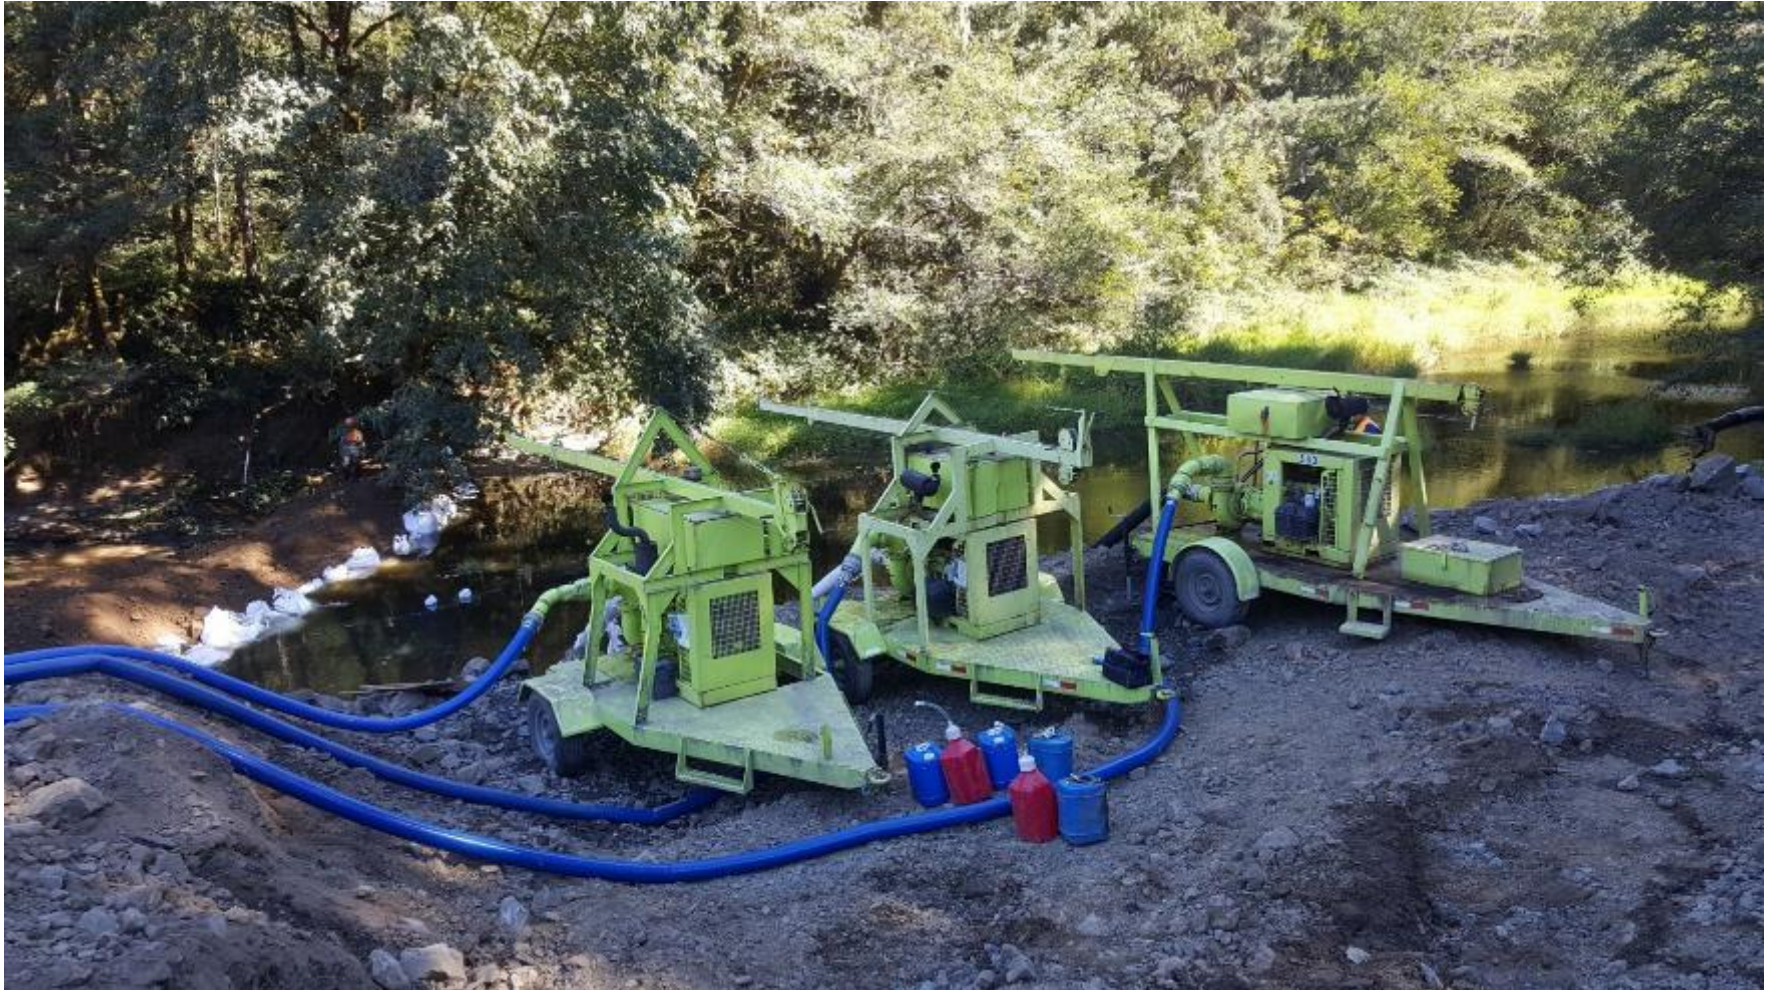
- **Three six inch river pumps were used for 24 hours to re-prime the oxbow before moving the river.**

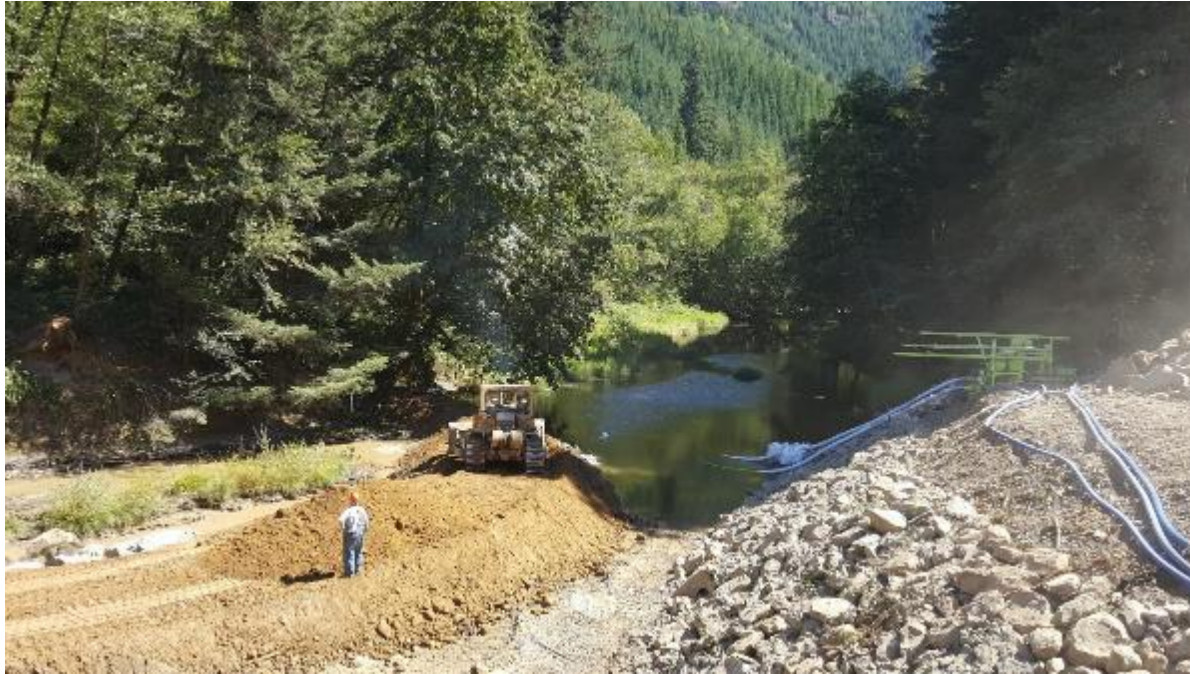
- **The three six inch river pumps also helped maintain river depths on the coffer dam built to protect the engineered fill on the bypass plug.**
