East Fork Oxbow Project

Jason Richardson, P.E.

Location: Coos Bay, Oregon on the Weyerhaeuser Millicoma Tree Farm.

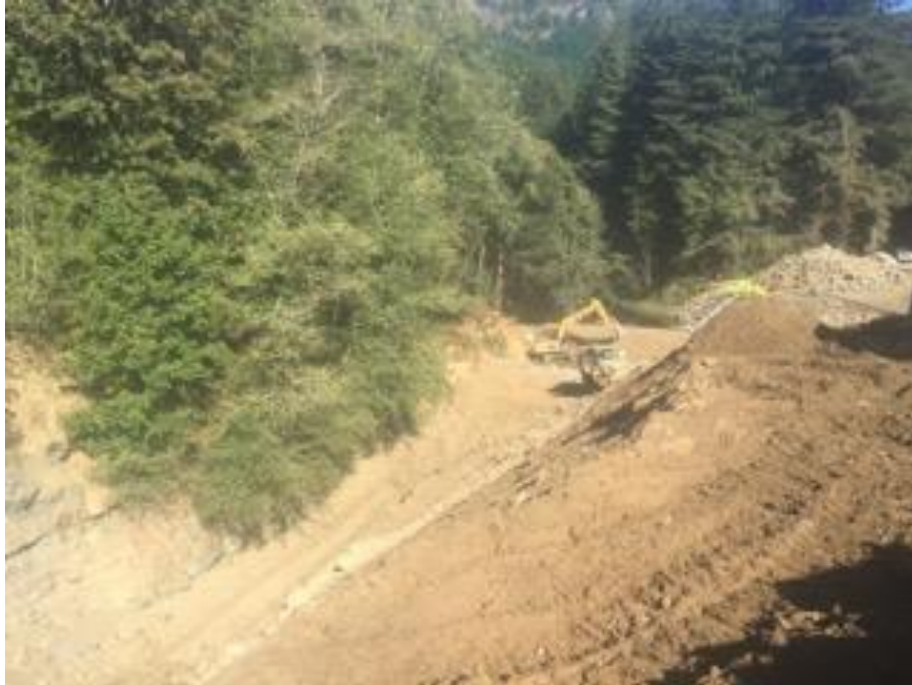
- **Engineered fill behind the coffer dam August 23rd 5:00 PM.**

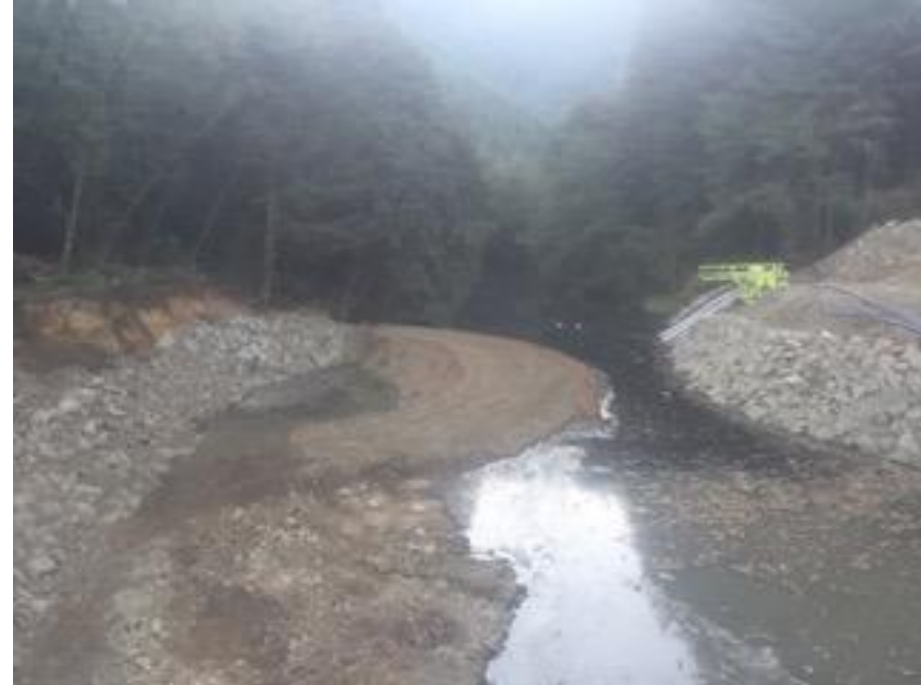
- **Coffer dam at top of bypass chute plug August 24th 6:30 AM.**
- **River now has a natural 1/4 mile pool backed up before bridge #5.**

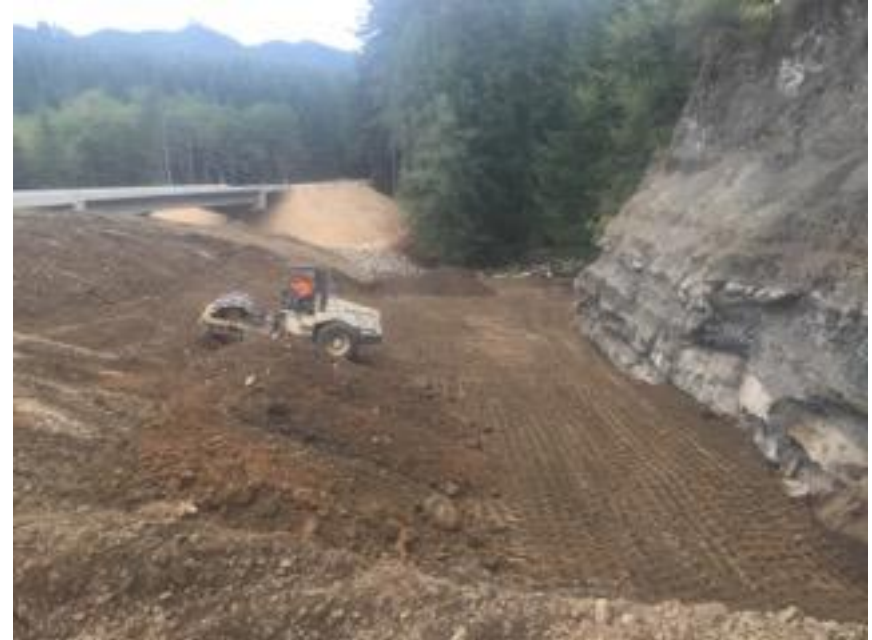
- **After the river was diverted the remaining fills were placed and final rip rapping along toe of new bypass chute plug.**
